WATER QUALITY MASTER PLAN

THE VILLAGE OF ARDEN, DELAWARE

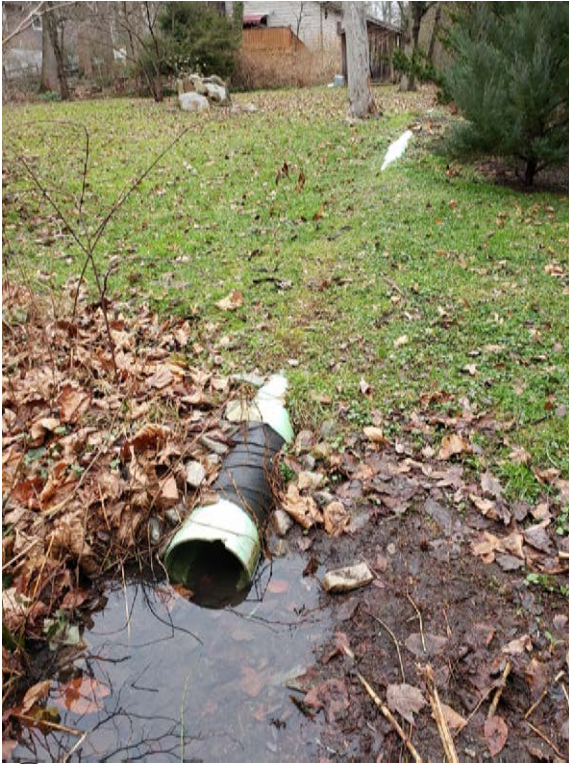
a

There are two catch basins at the north end of Sherwood Road. These two connect under the road and are piped out to the west towards the fire road within Sherwood Forest. This image is of the outfall to those catch basins. Debris collection was observed on the catch basins but overall, the system appeared stable.

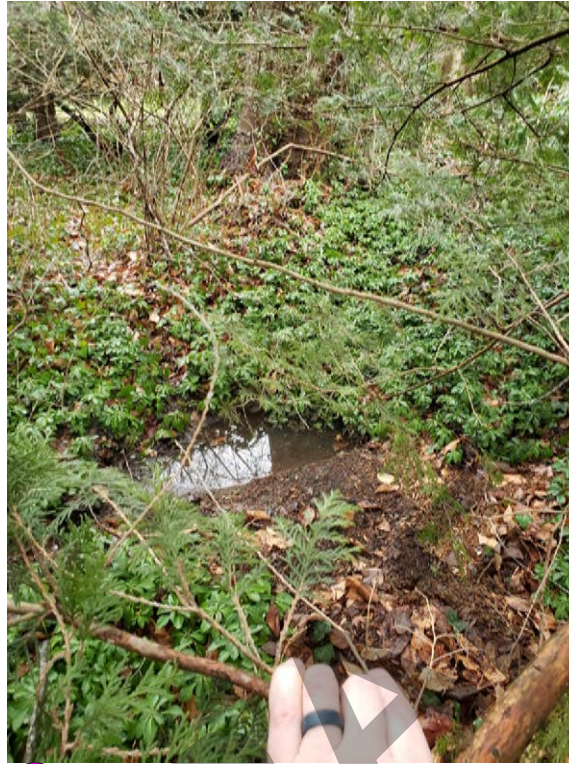
b

There are two catch basins at the intersection of Sherwood Road and Lovers Lane. These two connect under the road and are piped out to the west towards Sherwood Forest. This image is of the outfall to those catch basins. Debris collection was observed on the catch basins but overall, the system appeared stable.

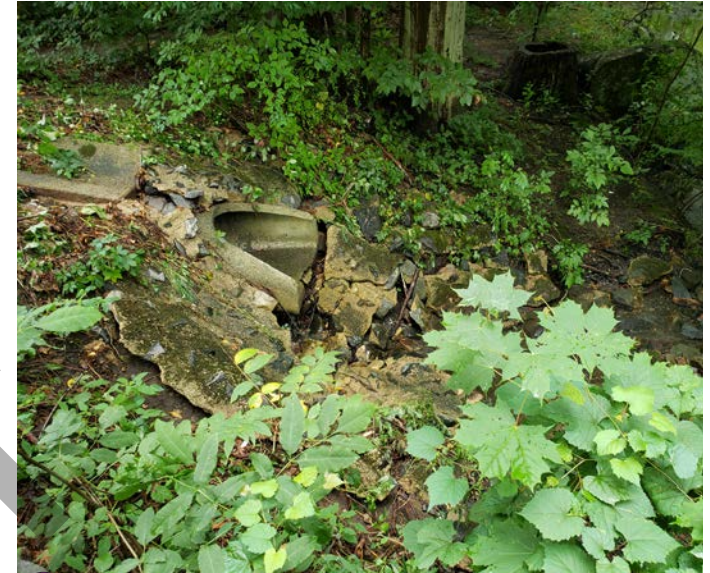
c2

This image shows the failing concrete outfall of the drainage network for c2. ForeSite was called to a site visit when the paving along Meadow Lane subsided after a large rain event. ForeSite provided recommendations for repairs to the outfall area. This network appeared in poor condition with multiple areas of the drainage system failing. The two catch basins on Harvey Road appear critical to the function of this system. Since they are not under the jurisdiction of Arden it is suggested that Arden monitor these two catch basins and request they be cleaned as debris collection impairs the function of the network to collect stormwater runoff.

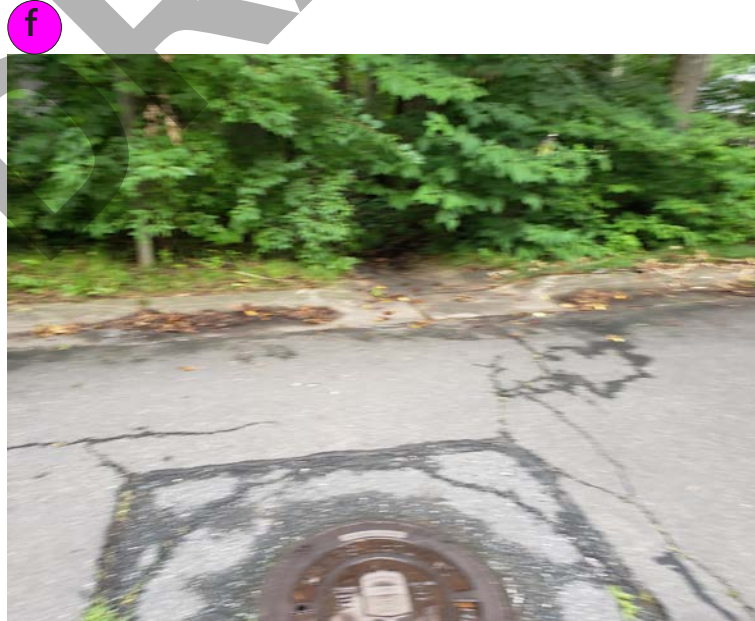
f

At the bottom of Little Lane is a small drainage network that has caused a significant amount of forest erosion. The network is simple with two catch basins at the end of Little Lane that connect underground and outfall just to the other side of Millers Road in the woods. There is a concrete gutter to catch road run off that sits on top of the outfall pipes. From this point just after the road stormwater is unmanaged down to the creek.

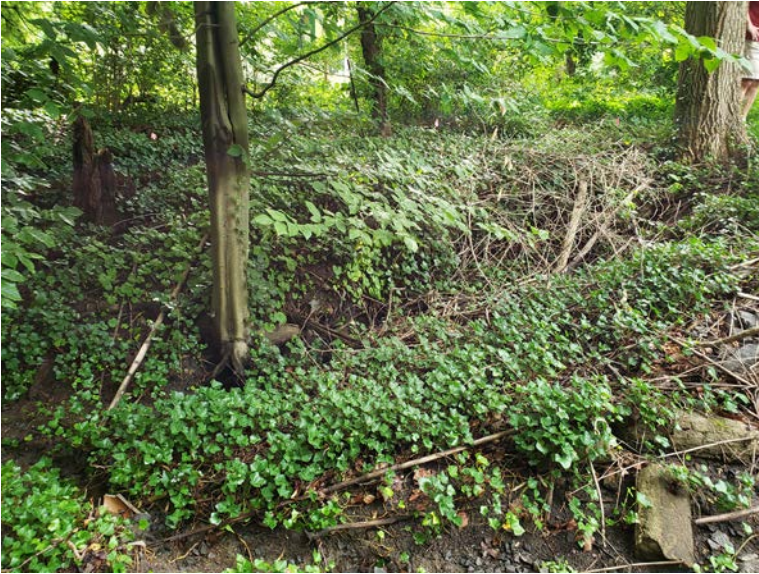
The g1 and g2 networks outfall in roughly the same location such that a bowl shaped depression, per the image, has formed in the landscape. The area is eroded but benefits from the repairs done to the sewer on the downslope side of the collection area. The stabilized drop in the area of the sewer likely slows the water down in this area, and slows the severely eroded channel downstream from eroding further up into the landscape.

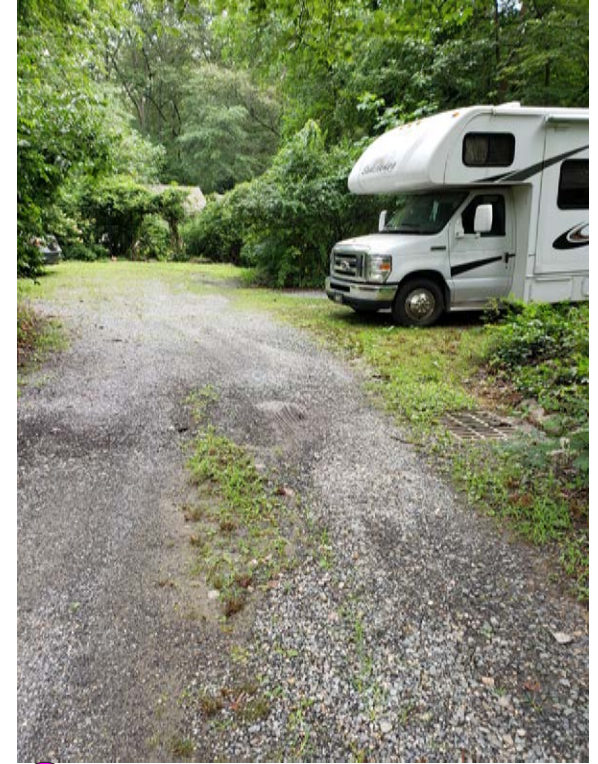
g1

This image illustrates the catch basin network that has a visible pipe outfall in the bowl area pictures previously. The catch basin in the middle right of the image connects to that outfall downstream and upstream connects to the catch basin in the outdoor theater at the base of the stage.

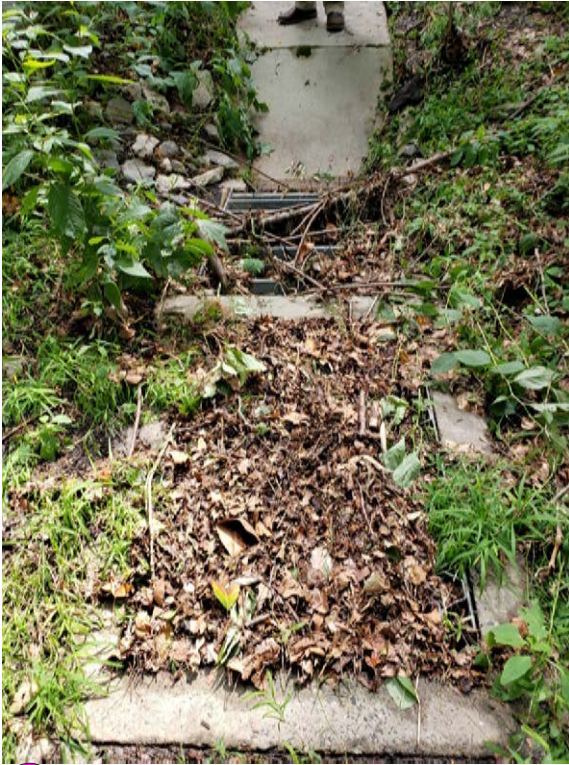
g2

This is the bottom catch basin for the drainage network of catch basins along St. Martins Lane. The structure was clogged with debris and larger sticks but overall appeared in solid condition. The water from this system travels under the driveway to outfall to a swale that leads to the bowl area pictured previously.

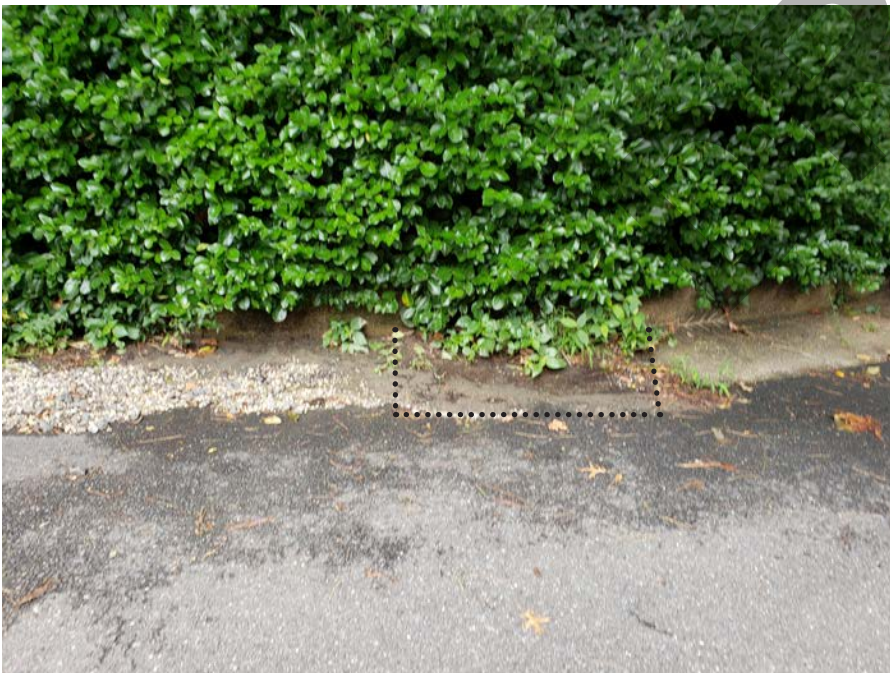
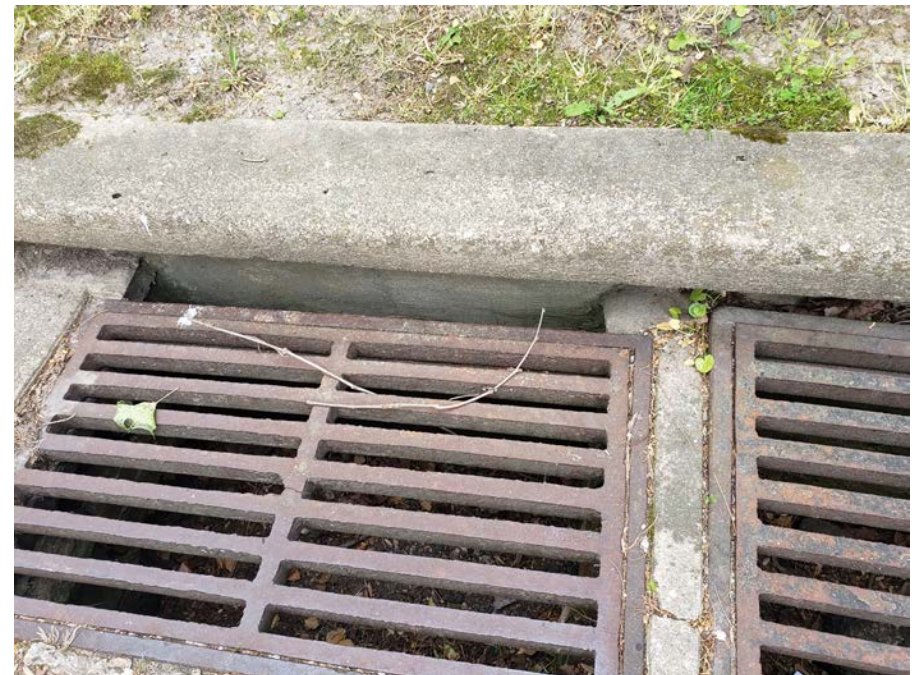
Not all catch basins work the same. The image to the right shows a traditional flat catch basin. This style is usually less costly at implementation but overtime loses function and often creates more costly fixes downstream. As illustrated in the image, they easily clog with debris and once clogged the water seeks a new flow path. The image on the bottom left is the most ideal style and as catch basins are replaced in Arden, it is recommended all basins be transitioned to this style. The grate works as a traditional flat basin but should the grate be clogged or become clogged during a heavy event, such as a large rainfall during the fall season when there are lots of leaves on the ground, the water will still be able to enter the drainage network via the open vertical area to the back of the catch basin. If there are concerns about small humans and animals getting caught, they do make vertical grates for these areas, even with a grate, the vertical rise area will continue to let water enter the network and drain properly.

The image to the bottom right illustrates a likely mis-installation of the same catch basin to the bottom left. Note the grate is set too far back and while there appears to be a rear opening, none actually exists such that it is easily clogged with debris.

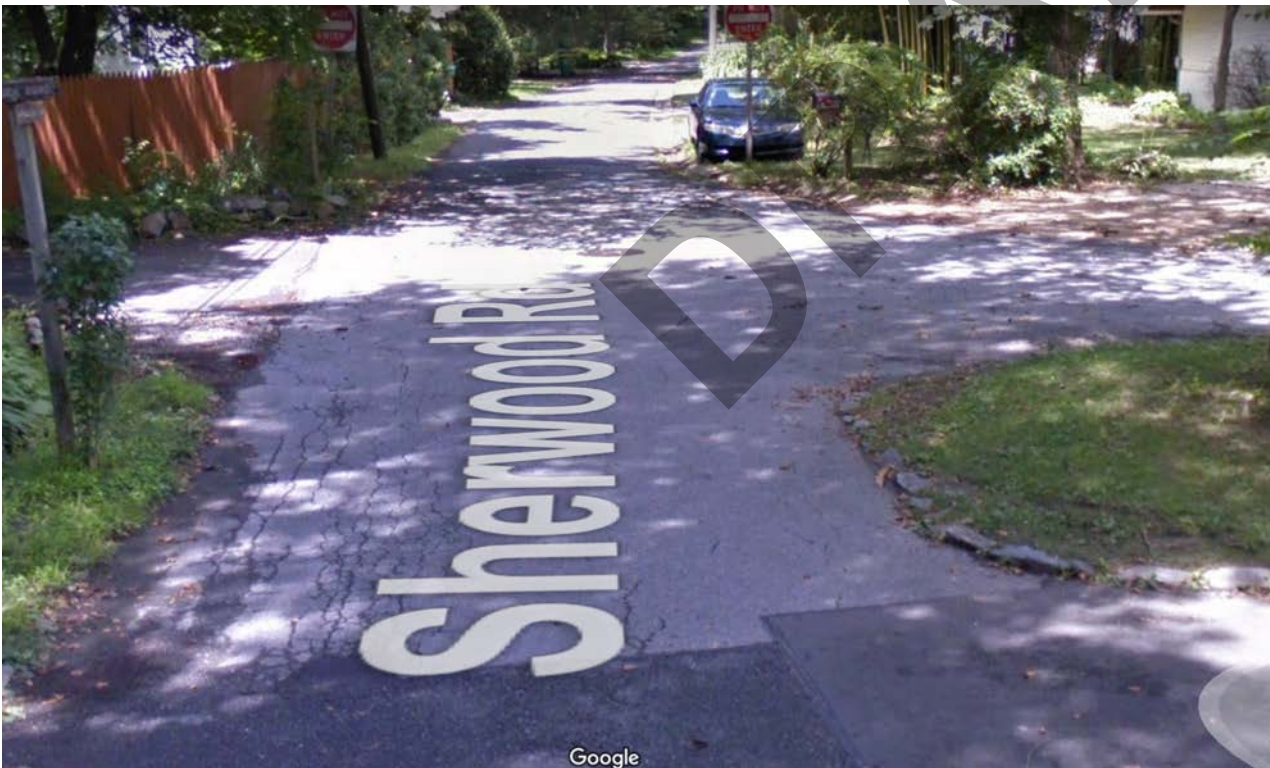
2

The wet soils and crackling pavement imply stormwater may not drain well from the roadway in this area. Site observations suggest when road runoff gets to this intersection there is no defined drainage path. Factors likely contributing to the lack of defined drainage include a slight curb on the north side of the island creates a dam effect where water likely puddles, and on the east side of the road the concrete gutter ends prior to the intersection leaving an undefined flowpath for upslope road runoff.

To assist in treating water quality and reducing storm surge downstream, it is suggested a bio-retention garden be installed in an area of paving removal. The proposed system suggests removing the catch basins and speed bump to ensure road run-off reaches the garden, installing a concrete road gutter on the west side of the road to direct drainage to this location, repairing the east side gutter as needed, and installing a concrete valley gutter to direct water across the road and into the garden. It is recommended the intersection have a reduced radius on the south side and the existing island be paved, to provide area for the BMP and vehicle maneuvers. The entire intersection from the end of Watershed A should be re-graded to slope to the garden, as illustrated with the dotted blue line arrow. Given the lack of sewer infrastructure and the existing downstream catch basin network, it is likely feasible to connect the bio-retention garden's under-drain and overflow system to the existing storm drain network at the intersection of Lover's Lane. The large pine is assumed to have more of its root structure growing towards the open grass areas and not toward the existing road. It is anticipated in this plan to remain; it is strongly suggested a certified arborist be contacted as required to protect the tree during construction.

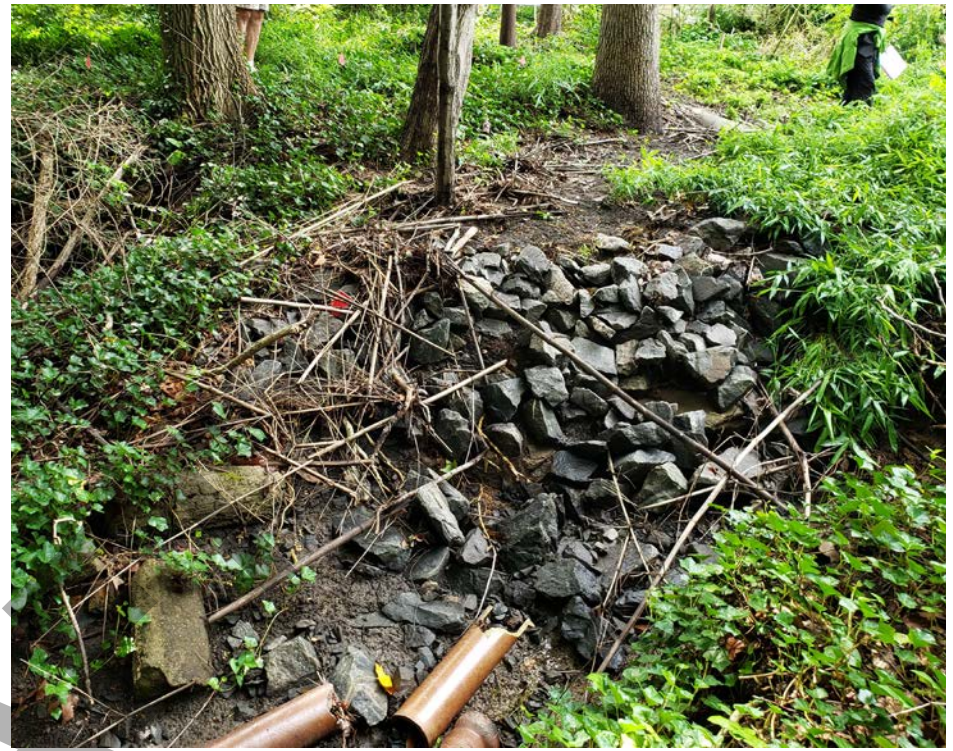
2 Outfall of the theater pipe into the woods. Photo taken from downstream. The dark void in the rip rap slope is the outfall.
